GROUP
ChassisNUMBER
010MODEL
SorentoDATE
December 2002

Technical Service Bulletin

SUBJECT**Sorento EX Steering Feel**

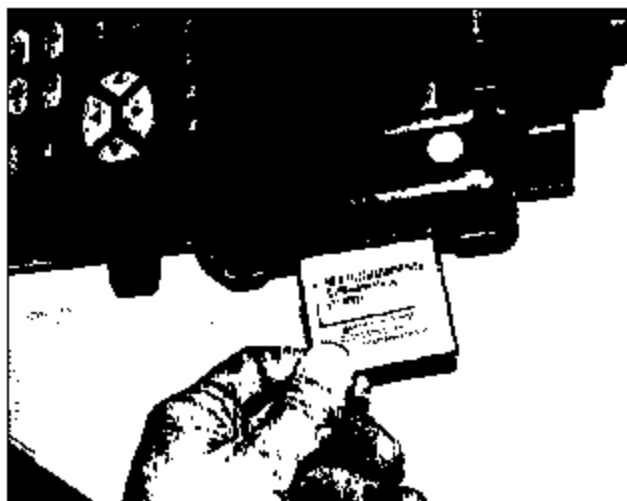
1. Remove program card from the upper slot of the Hi-Scan Pro and insert the reprogramming card.
2. Connect the Hi-Scan Pro to the under hood data link connector using the red 20 pin adapter.
3. Turn ignition key on.
4. Turn Hi-Scan Pro tool on, select "07 SORENTO STEERING IMPROVEMENT" then press the "ENTER" key.
